# CHRONOLOGY OF EXPLOSIVES AND PROPELLANT PLANT 55 PAVLOGRAD, USSR

JANUARY 1968
COPY 116
17 PAGES

NATIONAL PHOTOGRAPHIC INTERPRETATION CENTER

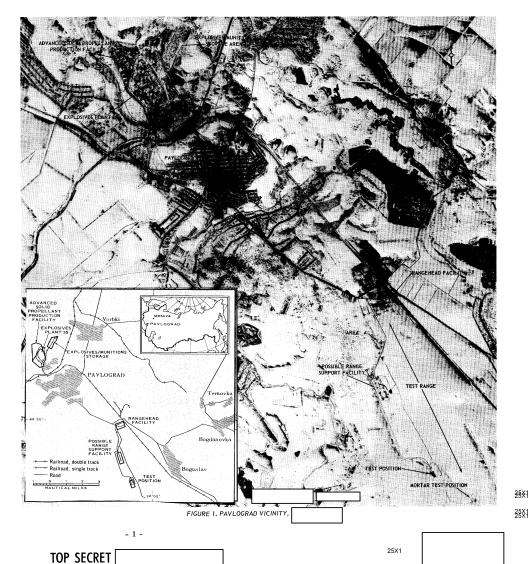
Explosives and Propellant Plant 55 Pavlograd Explosives Plant) is located 2 nautical miles (nm) northwest of Pavlograd, USSR, at 48-33-50N 035--50--40E (Figure 1). The installation consists of the original Explosives Plant 55, known to be in existence in 1943, and the adjoining Advanced Solid Propellant Production Facility, a new addition which has been under construction since 1962 and is still incomplete (Figures 1, 2, 3, and 4). Associated with the plant is an Explosives/ Munitions Storage Area located immediately northeast of Explosives Plant 55 (Figure 1).

In the immediate vicinity of Pavlograd is a Test Range, which is approximately 16 nm long and extends southeast from a Rangehead which is located at 48-29-50N 035-56-55E about 6.5 nm southeast of Explosives and Propellant Plant 55 (Figure 1). A Possible Range

east of the Possible Range Support Facility at 48-26-25N 035-58-00E (Figure 1). The Test Position (Figure 1) has been in operation at least since 1966 and therefore may

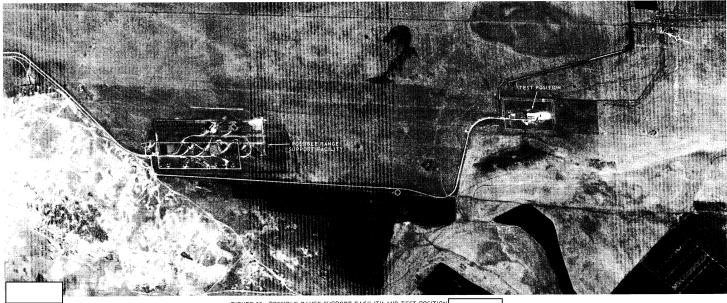
FIGURE 13. POSSIBLE RANGE SUPPORT FACILITY AND TEST POSITION,

a rail spur to the Possible Range In Support Facility (Figures 13, 14, and 15) was evident. Two buildings were present and the facility was fenced. A weapons test cell (since removed) was located approximately 0.25 nm southwest of the Possible Range Support Facility. In 1963 the Range Support Facility showed the addition of a second security fence. Two new rail beds and the completion of 3 medium and 6 small structures were also observed. No significant changes occurred to the facility in 1964. In 1965, two medium-sized support buildings (items 11 and 15, Figure 14) were completed along with another security fence. In 1966 one additional irregularly-shaped building (item 8) was completed. In 1967 one large and 1 medium building (items 12 and 14) were completed. The most recent photography suggests that the facility is being enlarged by approximately 20 percent and roads/railbeds are being extended within the facility. Data on the structures of the facility are presented in Table 3.

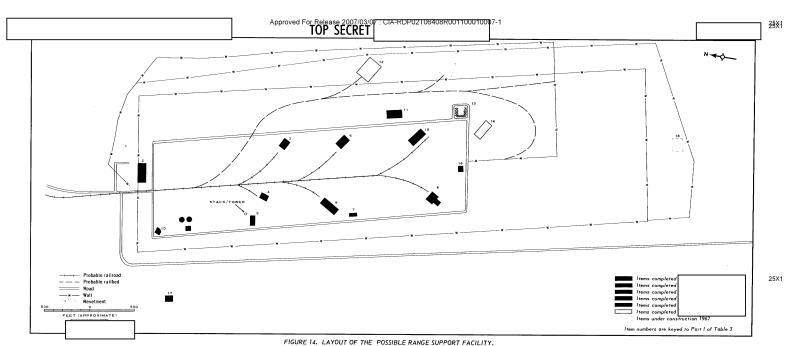
Table 3. Possible Range Support Facility and Test Position (Item numbers are keyed to Figures 14 and 15)

A road-served Test Position (Table 3 and Figure 15) is located 1.5 nm south of the Possible Range Support Facility. A Mortar Test Position (Figure 1) is located 0.75 nm southeast of the Test Position.
